Chipping of veneering ceramic on a lithium disilicate anterior single crown: Description of repair method and a fractographic failure analysis

Garbelotto, Luis G D ; Fukushima, Karen A ; Özcan, Mutlu ; Cesar, Paulo F ; Volpato, Claudia A M

Journal Article

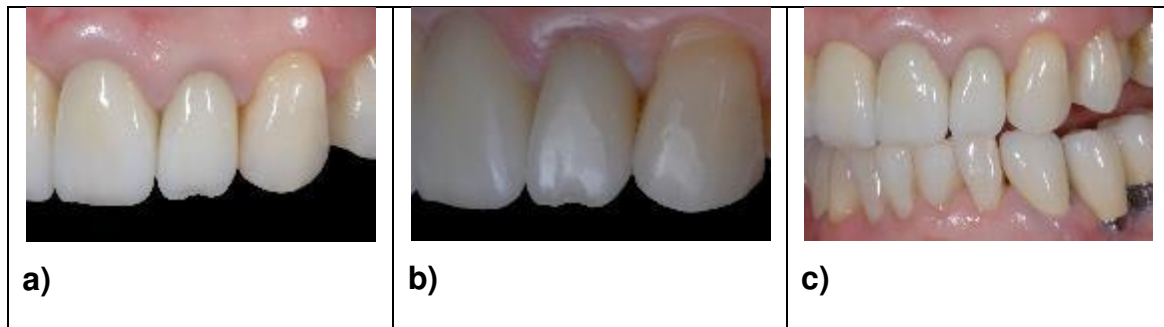
A 60 years old male patient was rehabilitated in April 2014 with anterior all-ceramic crowns constituted with a lithium disilicate based glass-ceramic framework veneered with feldspathic porcelain. After one year, in a follow-up session, a failure by chipping of the veneering ceramic was observed at the incisal edge and involving a small part of the labial surface of the tooth 22. In the clinical exam, an occlusal interference was found in the incisal edge of the refereed tooth, which probably led to chipping of the feldspathic porcelain (Figures 1a-c). The fracture was relatively small, had elliptical shape, its linear size from the incisal edge to

the end of the fracture was 2mm. Due to the small size of the fractured area (chipping grade 2),¹ an intra-oral repair with resin composite was indicated.

In this case report, the decision to make an intra-oral repair was related to the reduced size of the fractured area and the microstructure of the exposed ceramic substrate. During the clinical examination an occlusal interference was detected in the restored tooth and identified as the cause of the fracture event.^{8,9} The fractographic analysis indicated that the fracture of the porcelain layer initiated at the incisal edge where an area of multiple damage accumulation was present. This damaged area was probably created by the occlusal interference, and resulted from the constant attrition/impact of the lower incisor on the incisal edge of the upper lateral incisor. Each time the lower incisor hit the edge of the upper incisor, multiple small cracks propagated by the mechanism of slow crack growth that was enhanced in saliva. As a result, a damaged area was created and a larger crack propagated from the incisal causing the chip seen in Figures 3, 4 and 5. Unfortunately, as seen in many clinical cases, it is difficult to measure the size of the fracture origin, as it was related to a complex damaged area.

Figures 1a-c Photos of a) chipping of the veneering ceramic (22), b) side view of chipping, c) presence of the occlusal interference.

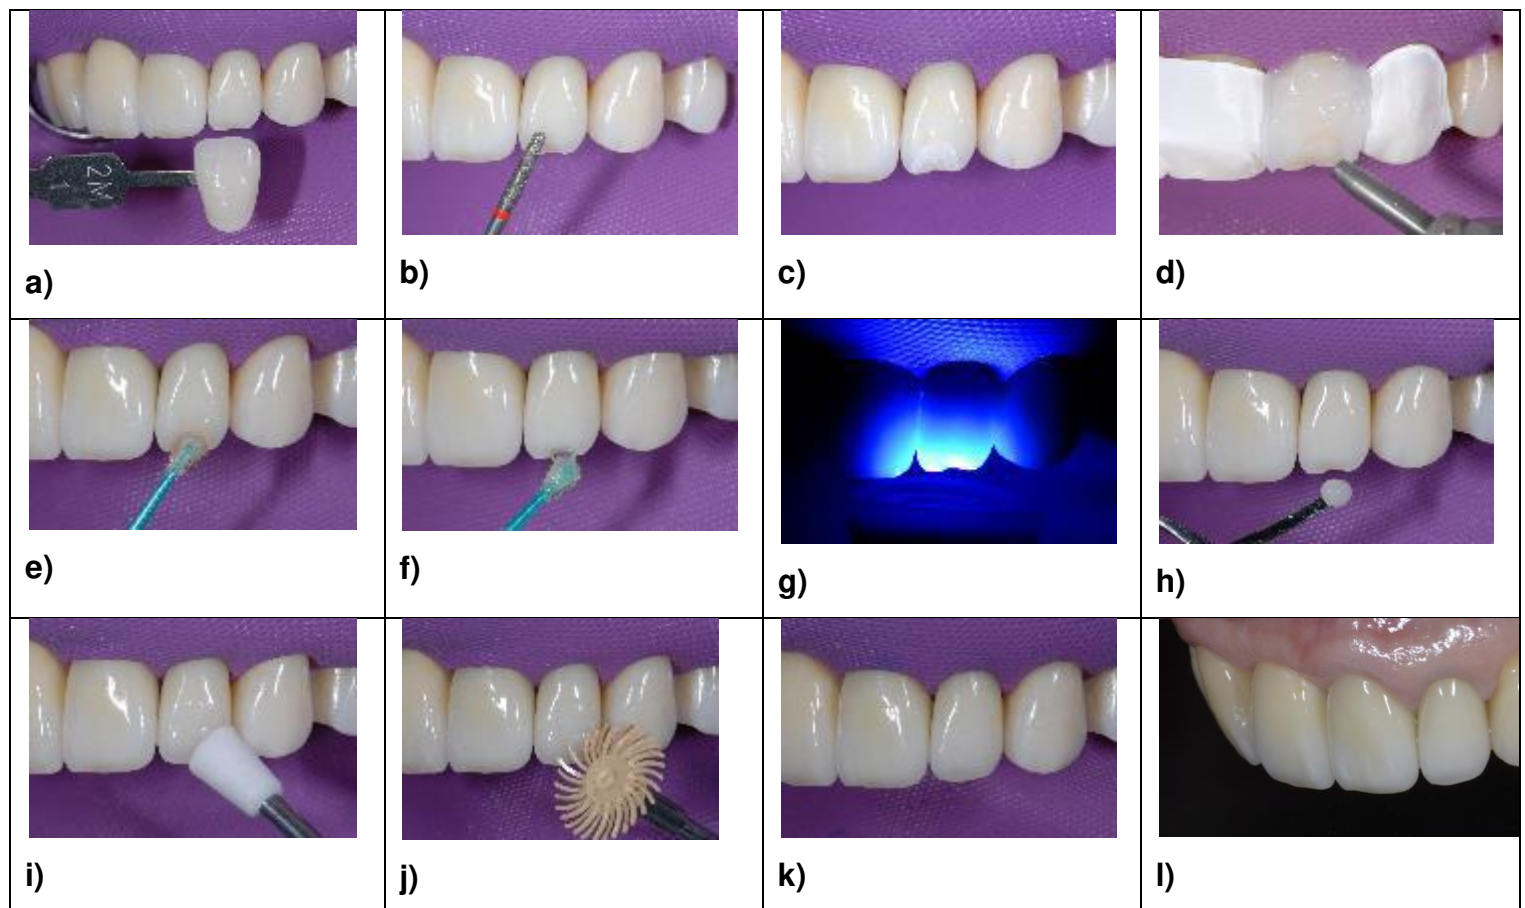
Figures 2a-l Photos of a) shade selection (22), b,c) removal of the glaze layer, d) protection of the prosthesis and veneering ceramic, e) hydrofluoric acid, f) silane coupling agent, g) curing of the adhesive resin, h) composite resin, i,j) finishing and polishing, k) intra-oral repair, l) follow-up after one year.

Since the fracture of the restoration did not expose the lithium disilicate infrastructure, the classic technique for adhesion to feldspathic porcelains was used. This is a predictable technique because it uses hydrofluoric acid (HF) associated to posterior silane application in order to obtain good bond strength between the porcelain and composite resin.¹⁴ The clinical procedure was performed with absolute isolation to protect the soft tissue from the hazardous effects of the hydrofluoric acid and to avoid saliva contamination during the adhesive procedure.¹⁴

Initially, the restoration shade was selected with the help of a color guide (Linearguide 3D Master, VITA Zahnfabrik, Bad Säckingen, Alemanha). After cleaning the fractured area with fluorine-free paste and properly isolating it, the glaze around the fractured ceramic area was removed with a fine-grained diamond bur, creating a slight bevel. This approach homogenized the surface roughness and allowed for a smoother transition between the resin composite and the porcelain.⁶ The adjacent prosthesis was protected with a polyfluorethylene tape and the remaining porcelain material in tooth 22 was protected with glycerin gel. Sandblasting was performed for 10 seconds, with silica particle size range of the 50µm, blasting pressure at 2.5 bar and at a distance of 10 mm in circling motion, rotating the nozzle (Microetcher, Danville Engineering, Danville, CA, USA).

After air-abrasion, the bonding area was washed, cleaned with 70% alcohol and conditioned with 10% hydrofluoric acid (Porcelain Etch, Dentisply, York, PA, USA) for 2 minutes. The area was then thoroughly washed again and dried. A silane coupling agent (Ceramic Primer, 3M ESPE, St. Paul, MN, USA) was applied for 3 minutes and dried with oil-free air. Silane application is recommended to create covalent bonds between the surface of the feldspathic porcelain and the bonding agent¹³. A bonding agent

(Optibond FL, Kerr Corporation, Orange, CA, USA) was then applied to the ceramic surface and photo cured for 20 seconds. The intra-oral resin composite repair (Estelite Sigma Quick, Tokuyama Dental Corporation, Tokyo, Japan) was constructed using the incremental technique. Finishing and polishing procedures were done with rubber tips (Flexi Cups, Cosmedent, Chigaco, IL, USA; Soft-Lex Spiral Finishing, 3M-ESPE, St. Paul, MN, USA) and polishing paste (Porcelize, Cosmedent, Chicago, IL, USA).

After removal of the rubber dam, the occlusion was checked with carbon tapes and the adjusted area was repolished with rubber tips. This step is critical to minimize the recurrence of the failure due to occlusal overloading.^{7,10,13} The sequence of clinical procedures is shown in Figures 2a-l. The patient authorized data collection the use of his clinical images by means of signing the Informed Consent Term. All data regarding the restorative steps were retrieved and analyzed.

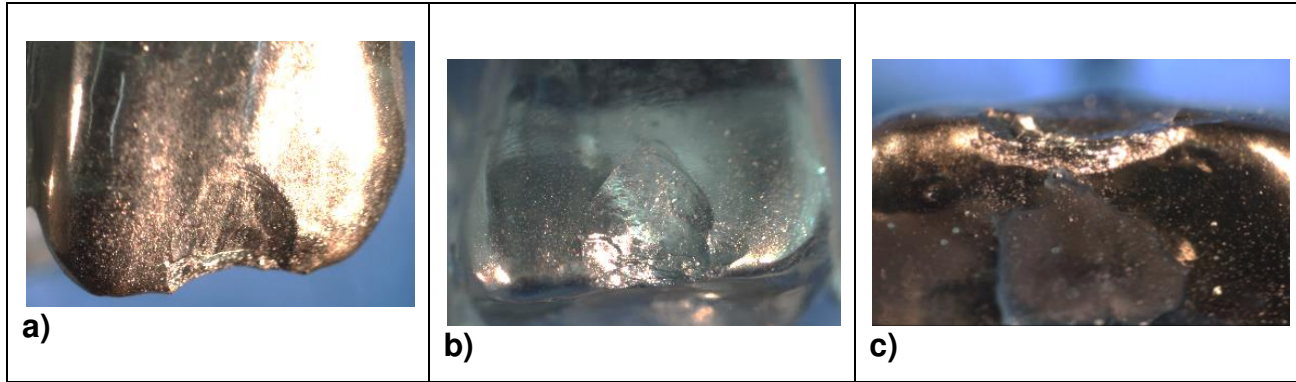
The analysis of the fracture surface under stereomicroscope clearly shows that the fracture initiated at the incisal edge, where it is possible to note an area of damage accumulation (Figures 3ab) most likely due to the fact that the incisal edge of the lower incisor hit many times this area after multiple mastication cycles. The chip fracture was wider at the incisal edge and became narrower towards the cervical direction, resulting in a triangular shape (Figure 3a). Far from the incisal edge, at the labial side, it is possible to clearly note multiple arrest lines with their convex sides facing the incisal edge, which indicates that the

direction of crack propagation was from incisal edge towards the cervical region. The palatal view (Figure 3c) shows the incisal area with damage accumulation, which was the origin of the fracture event.

Figures 3a-c Photos of a) labial view of the crown (22), b) fragments of the horizontal fractured area, c) coronal fragments just above the metallic insert.

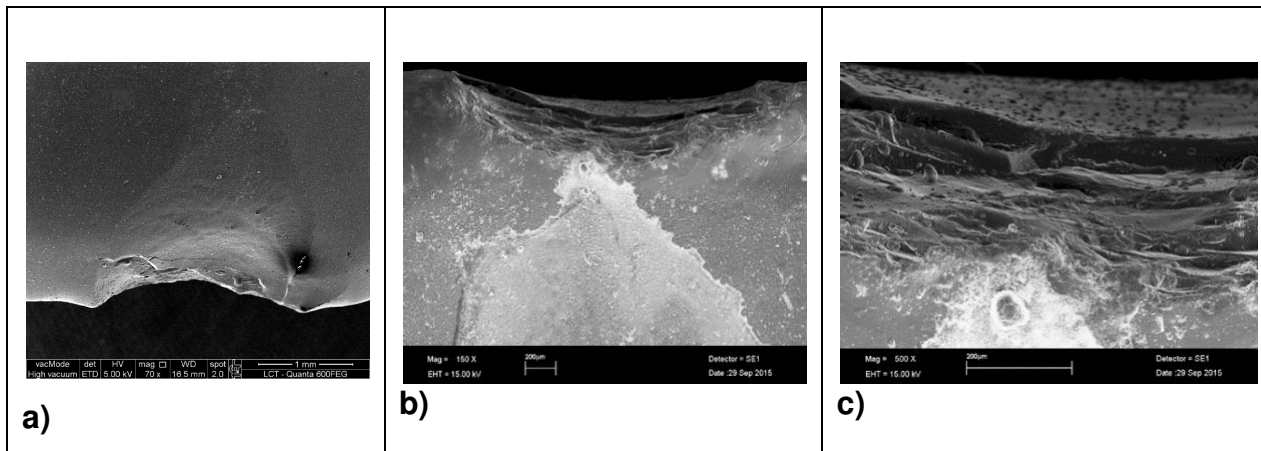
The SEM analysis (Figures 4 and 5) corroborated the information obtained in the stereomicroscope. Figure 4a shows an overview of the chip; it is clear that the origin was at the incisal edge, where multiple damage accumulation areas can be noticed. Towards the cervical area, multiple arrest lines in the form of half ellipses are seen along with numerous hackles and wake hackles that propagated up to the end of the fracture event in the region where the chip became narrower. Figure 4b shows a palatal view of the tooth where it is possible to note the damage zone in the incisal edge where the fracture started.

Figures 4a-c a) Overview labial view, b) incisal/palatal view at lower magnification and c) higher magnification.

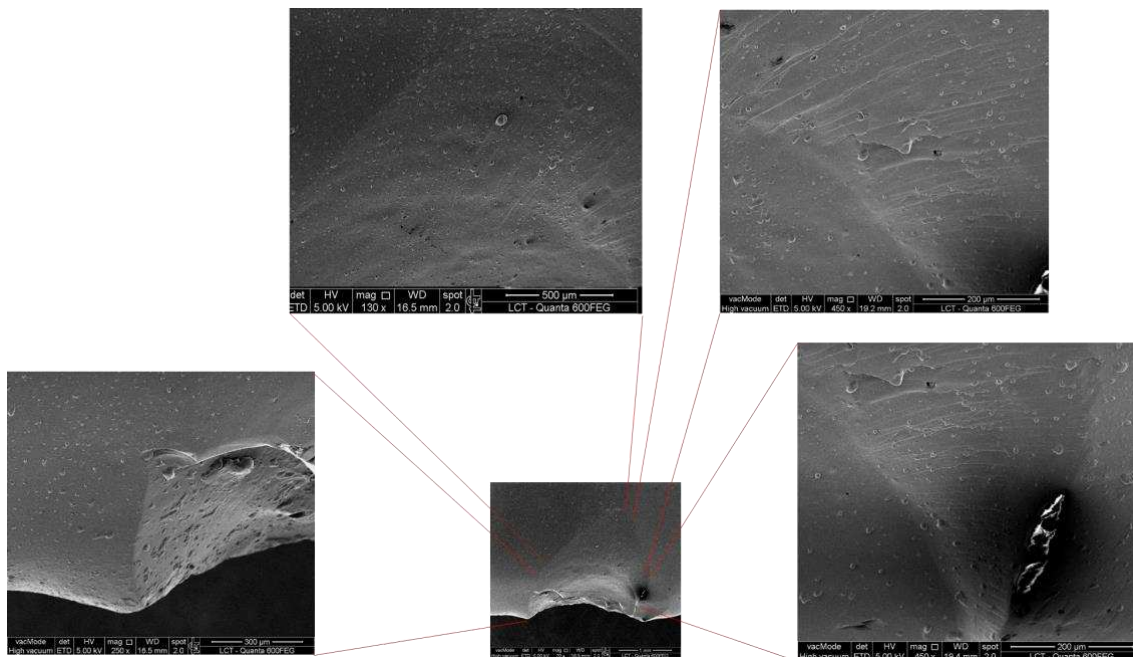
Figure 5 shows the detailed mapping of the entire fracture event under SEM. In the center of this figure, it is possible to note the overview of the chipped area. The surrounding micrographs present higher magnifications of the areas of interest. In Figure 5a, it is possible to note the damage zone area delimited by concave cracks at the top. Figure 5b shows multiple arrest lines and many hackles and wake hackles indicating that the direction of crack propagation went from the incisal edge to the cervical area. Figures 5c and 5d also show arrest lines with hackles and wake hackles indicating that in this area the crack propagated from the incisal edge to the distal surface of the incisor.

Figure 5a-d SEM – Mapping of fracture surface.
